BELZONA REPAIRS IRRIGATION HOSE

ID: 5916

Customer Location: Northwestern Washington, USA
Application Date: September 2015

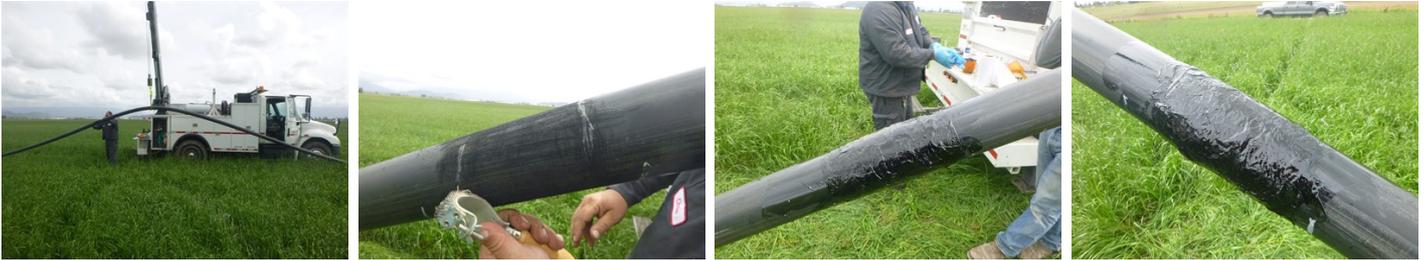
Photograph Descriptions

A small crack formed from hose working on and off the reel.

- * Hose lifted to a working height. ,
- * Roughing brush used to obtain a rough surface profile. ,
- * Belzona 2111 with Belzona 9341 applied over the conditioner. ,
- * Completed application. ,

The pipe was lifted to working height for preparation and application. Then, the pipe was scuffed with a roughing brush for 2 inches on both sides of the crack. The pipe was conditioned before applying a layer of gelled Belzona 2111, followed by Belzona 9341 and an overcoat of Belzona 2111.
