BELZONA PROTECTS SLUDGE PUMP

ID: 592

Casing of a sludge pump

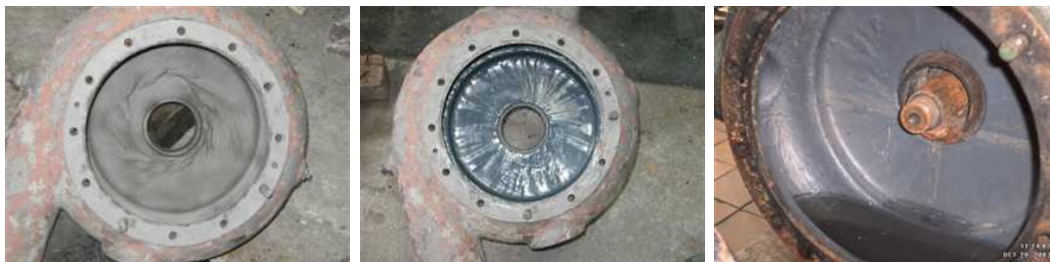
Pump casing severely eroded and corroded during operation.

* Worn out pump casing. , * After Belzona® 1321 application. , * Inspection view 600 working hours after application. ,

Pump suffered very low efficiency and was considered to be scrapped. Belzona was chosen both on basis of cost and fast turn-round. Inspection after 600 working hours showed the pump casing was still in excellent condition.

Application procedure was carried out in accordance with Belzona Know-How System Leaflets CEP-3 & -5.
