# BELZONA REPAIRS BROKEN FLANGE

ID: 5922

Semi-fine limestone material transfer pipeline system.

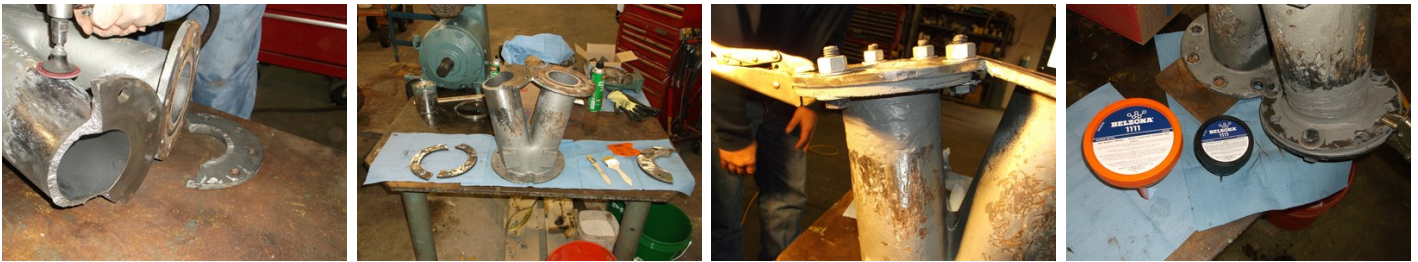
Broken flange collar was causing material to spill out when in operation.

- \* View of the broken flange and removing paint to prepare surface ,
- \* Broken flange in the center, broken piece to the right and the steel backers to the left, ready for the application ,
- \* Side view of completed flange repair ,
- \* Top view of completed flange repair ,

A 2-piece steel backer was built to bond to the broken flange for added strength. A grinder was used to roughen the application surface. It was then thoroughly cleaned and Belzona 9411 was applied to the bolts, washers, and nuts. A part of Belzona 9341 was pre-cut. A thin coat of Belzona 1111 was applied to all application surfaces and onto Belzona 9341. The application started by wrapping Belzona 9341 around the shoulder of the flange and then the broken piece was mounted back onto the flange using the steel backers. For a finished fit, the bolts were tightened down. Then, the remainder of Belzona 1111 was applied over Belzona 9341.
