# STRIPPED THREADS QUICKLY REPAIRED WITH BELZONA

ID: 5928

Customer Location: *Nashville, TN, USA*  
Application Date: *September 2015*

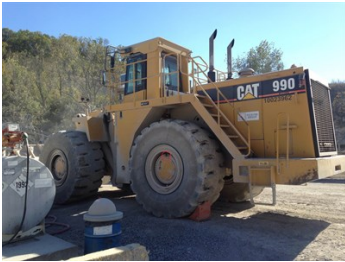
*The oil plug on a Caterpillar 990 Final Drive, had been stripped when someone used an impact wrench instead of hand tightening the bolt. The customer was faced with downtime of the equipment and expensive new parts.*

- \* Cat 990 with leaking oil evident ,
- \* Bolt cavity prepared for application ,
- \* Applying Belzona 1212 to threads on bolt and bolt cavity ,
- \* Completed application, bolt snugged down and waiting to go back into service ,

Stripped threads on a Caterpillar 990 Final Drive were leaking oil.
