STRIPPED THREADS QUICKLY REPAIRED WITH BELZONA

ID: 5928

Industry: *Mining & Quarrying*
Application: *ENC-Engines and Casings*
Substrate: *Steel*
Products: ** Belzona 1212 ,*
** Belzona 9411 (Release Agent) ,*

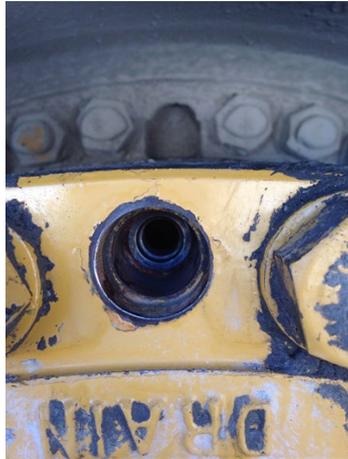
The oil plug on a Caterpillar 990 Final Drive, had been stripped when someone used an impact wrench instead of hand tightening the bolt. The customer was faced with downtime of the equipment and expensive new parts.

Stripped threads on a Caterpillar 990 Final Drive were leaking oil.
