BEARING HOUSING REPAIR WITH BELZONA

ID: 593

Centrifugal pump bearing housing

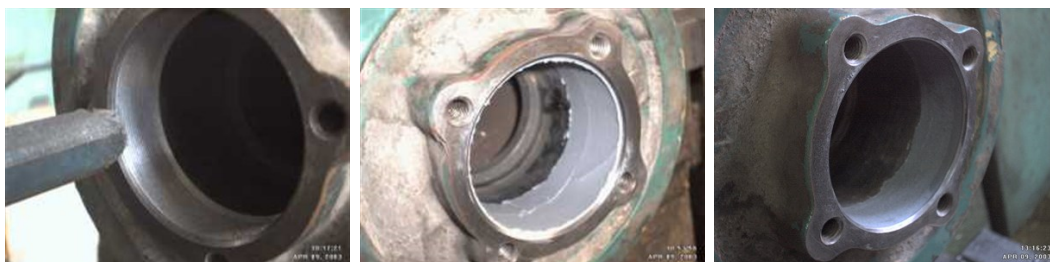
Photograph Descriptions

Housing damage after bearing seized leading to increased clearance.

- * Preparing surface ,
- * Belzona® 1111 applied ,
- * Housing with restored dimensions after machining ,

Application was carried out in accordance with Belzona Know-How System Leaflet MPT-6.
