# PROVEN BELZONA REPAIR AND PROTECTION OF FLOOR PROBLEM AREAS

ID: 5934

Customer Location: Correctional Facility, Missouri, USA

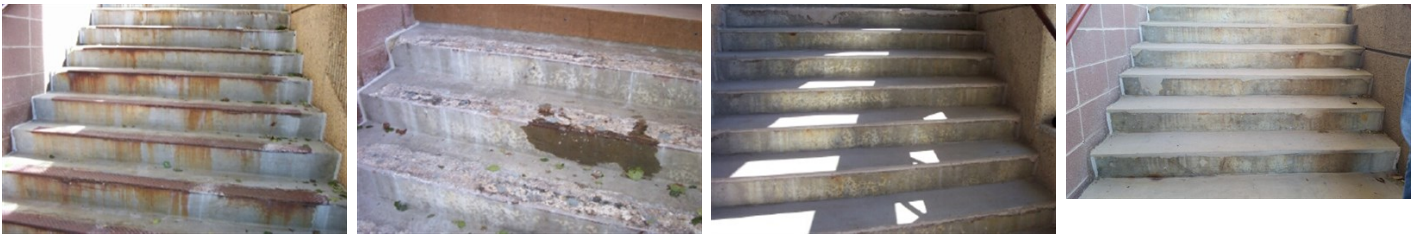
The metal treads on these stairs had come loose due to severe spalling around the fasteners. The corrosion of the treads had stained the risers and created an unsightly appearance. The conventional solution was a costly tear-out and replacement.

\* 1. Overview damage of treads on concrete steps 2. Damage to the concrete 3. Completed application 4. Inspection after 12 years shows steps to be in perfect condition ,

The application was carried out by the in-house crew with Belzona technical training. Lap siding was attached to the risers to use as formers and Belzona 4131 was applied to completely resurface the steps.
