BELZONA STOPS HIGH VOLTAGE CIRCUIT BREAKER LEAK

Customer Location: Electricity distribution company,
Queensland, Australia

Application: VPF-Valves, Pipes and Fittings

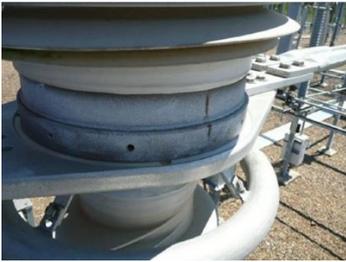
With a broken seal, SF6 gas was leaking into the environment. SF6 is potent greenhouse gas and subject to strict environmental control.

* 1. Damaged Circuit Breaker 2. Surface Preparation underway 3. Application of Belzona 1212 wrap being carried out. 4. Completed Application ,

An aging circuit breaker seal had failed.
