# BELZONA STOPS HIGH VOLTAGE CIRCUIT BREAKER LEAK

ID: 5935

Customer Location: Electricity distribution company,  
Queensland, Australia

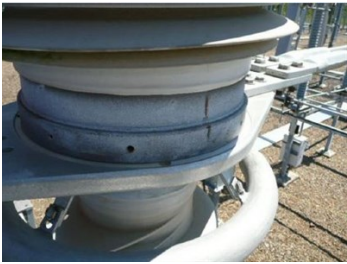
With a broken seal, SF6 gas was leaking into the environment. SF6 is potent greenhouse gas and subject to strict environmental control.

\* 1. Damaged Circuit Breaker 2. Surface Preparation underway 3. Application of Belzona 1212 wrap being carried out. 4. Completed Application ,

An aging circuit breaker seal had failed.
