BELZONA TIRE REPAIR QUICKLY GETS LOADER BACK IN SERVICE

ID: 5937

Repair of the tire sidewall on a front end loader.

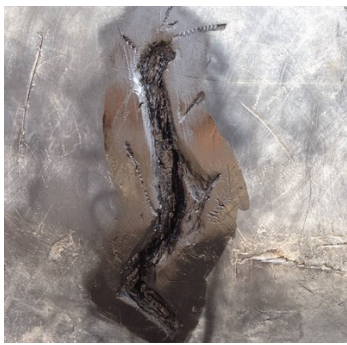
A large crack approximately 10 inches long and up to 2 inches deep had developed. There was no spare tire and removing it for vulcanization would leave the operation short of their only loader. This loader was used to supply materials for the entire block plant and without it, the entire operation is down. The deep crack was exposing radial belting and needed something to stop the moisture from attacking the steel radials and keep the crack from running further.

- * Crack cleaned, roughened, and conditioned. ,
- * Application of Belzona 2311. ,
- * Two weeks later, material which had exceeded the conditioned area had peeled and need to be trimmed off (always tape off your edges!). ,
- * Repair revisited 3 Months after application, Belzona still perfectly adhered. ,

The application was carried out in accordance with Belzona Know-How System Leaflet SHM-15. The area to be treated was cleaned with a cleaner/degreaser and then abraded using a wire wheel, Belzona roughing brush and rotary tool. After a final cleaning the area was treated with Belzona 2911 and allowed to dry for 30 minutes. Belzona 2311 was then used to coat the radials and rebuild

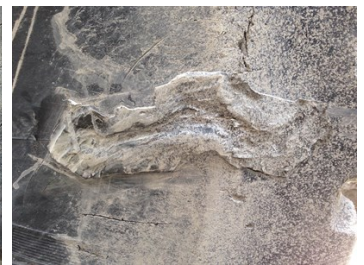
Due to downtime concerns, the loader could not be taken out of service for more than a few hours. A new tire was over \$4,000.00 and as long as the crack could be repaired this tire still had a lot of service life remaining. Belzona materials cost the customer less than \$75.00. The hoppers which fed the plant were filled before the repair was started and the repair was completed and cured before the hoppers needed to be refilled, costing them no downtime. This repair was revisited 3 months later and is still performing perfectly.
