# BELZONA TIRE REPAIR QUICKLY GETS LOADER BACK IN SERVICE

ID: 5937

Repair of the tire sidewall on a front end loader.

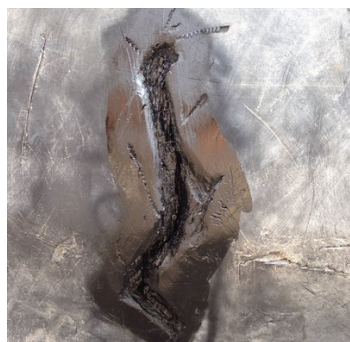
- \* Crack cleaned, roughened, and conditioned. ,
- \* Application of Belzona 2311. ,
- \* Two weeks later, material which had exceeded the conditioned area had peeled and need to be trimmed off (always tape off your edges!). ,
- \* Repair revisited 3 Months after application, Belzona still perfectly adhered. ,

The application was carried out in accordance with Belzona Know-How System Leaflet SHM-15. The area to be treated was cleaned with a cleaner/degreaser and then abraded using a wire wheel, Belzona roughing brush and rotary tool. After a final cleaning the area was treated with Belzona 2911 and allowed to dry for 30 minutes. Belzona 2311 was then used to coat the radials and rebuild
