BELZONA REPAIR KEEPS BELTS TRACKING

ID: 5939

Industry: General Industry
Application: SHM-Solids Handling Machinery

Substrate: PVC Conveyor Belt
Products: * Belzona 2311 (SR Elastomer) ,
* Belzona 2911 (Elastomer QD Conditioner) ,
* Belzona 9341 (Reinforcement Sheet) ,
* Belzona Roughing Brush ,

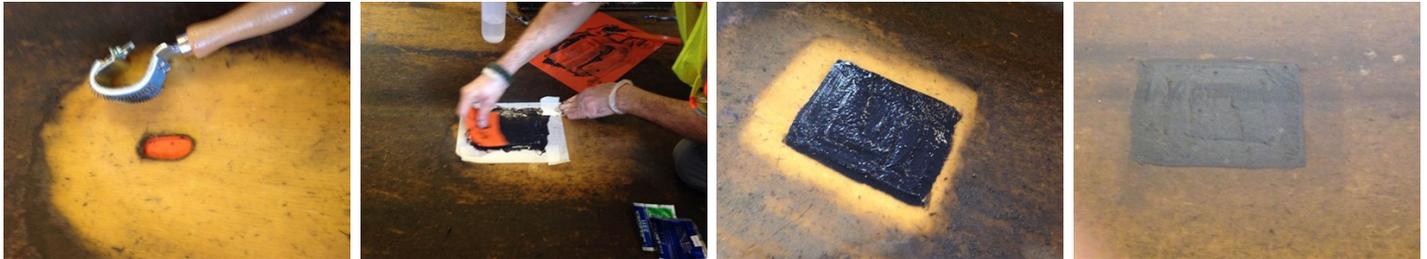
Photograph Descriptions

Several small holes in a thin (1/8') conveyor belt made of PVC were allowing debris to fall onto the conveyor belt bed and causing the belt to track improperly. Most of the belt was in good condition and the customer was looking for a solution to extend the conveyor belt lifetime rather than replace it.

- * Application area cleaned and conditioned ,
- * Application in progress ,
- * Repair completed ,
- * Repair re-visited after 4 weeks of impact and abrasion from sharp, shredded metal ,

The application was carried out using a modified version of Belzona Know-How System Leaflet SHM-1. The surface was cleaned using a cleaner/degreaser and roughened using the Belzona roughing brush. The area to be repaired was then taped off and conditioned with Belzona 2911 and allowed to dry until touch-dry. Since the belt was only 1/8' thick and not multi layered, it was not possible to remove the top layer and insert the repair material to create a flush surface. Alternatively, a mixing board was used as a backer to the area to be repaired. The hole was filled and the substrate coated with Belzona 2311. Then, Belzona 9341 was

embedded with Belzona 2311 and laid over the hole and topped with more Belzona 2311 so it would not leave the reinforcement sheet exposed. Two repairs were carried out in this manner as well as a smaller hole repair without the reinforcement sheet.
