# BELZONA PIPE REPAIR KEEPS COOLING TOWER IN SERVICE

**Industry:** Heating, Ventilation & Air Conditioning  
**Application:** VPF-Valves, Pipes and Fittings  
**Substrate:** PVC  
**Products:** \* Belzona 1161 (Super UW-Metal) ,  
\* Belzona 1321 (Ceramic S-Metal) ,

**Customer Location:** Nashville, TN, USA  
**Application Date:** May 2015

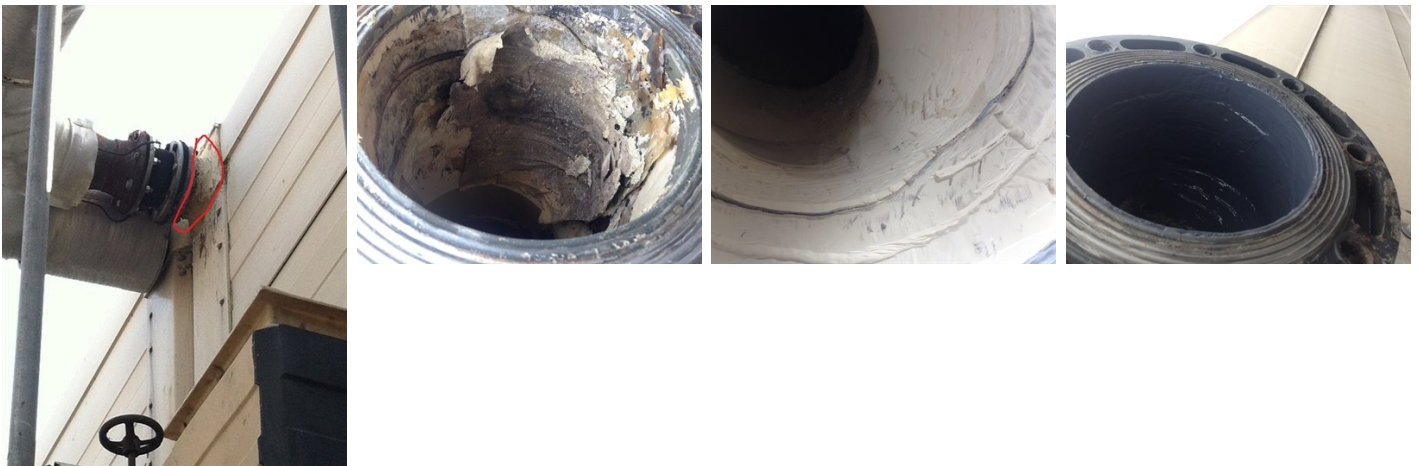
The water inlet on a cooling tower had developed a spiral crack due to the inflexible nature of the pipe and the movement of the cooling tower. It was leaking so badly that while the pumps were running, it would spray a stream of water over the side of the building onto walkways below.

- \* Remnants of previous attempts to repair the pipe externally ,
- \* Remnants of previous repair attempts inside the pipe ,
- \* Pipe and crack cleaned, roughened and ready for the Belzona application ,
- \* Repair completed, crack sealed with Belzona 1161 and an additional two coats of Belzona 1321 ,

The application was carried out in accordance with a combination of Belzona Know-How System Leaflets VPF-8 and VPF-11. A flexible joint was removed next to the leak to allow the repair to be conducted from the inside of the pipe. Materials used in a previous attempt to stop the leak were removed and the inside of the pipe was thoroughly cleaned and abraded using a rotary tool

and an oscillating tool. The crack was then v-ed out. Belzona 1161 was applied through the crack and two coats of Belzona 1321 were applied over this and for 6 inches in each direction from the repair for wear and erosion protection.
