# BELZONA REPAIRS BUTTERFLY VALVE SEALS

ID: 5941

**Customer Location:** Cement Industry, Nashville, TN, USA  
**Application Date:** February 2015

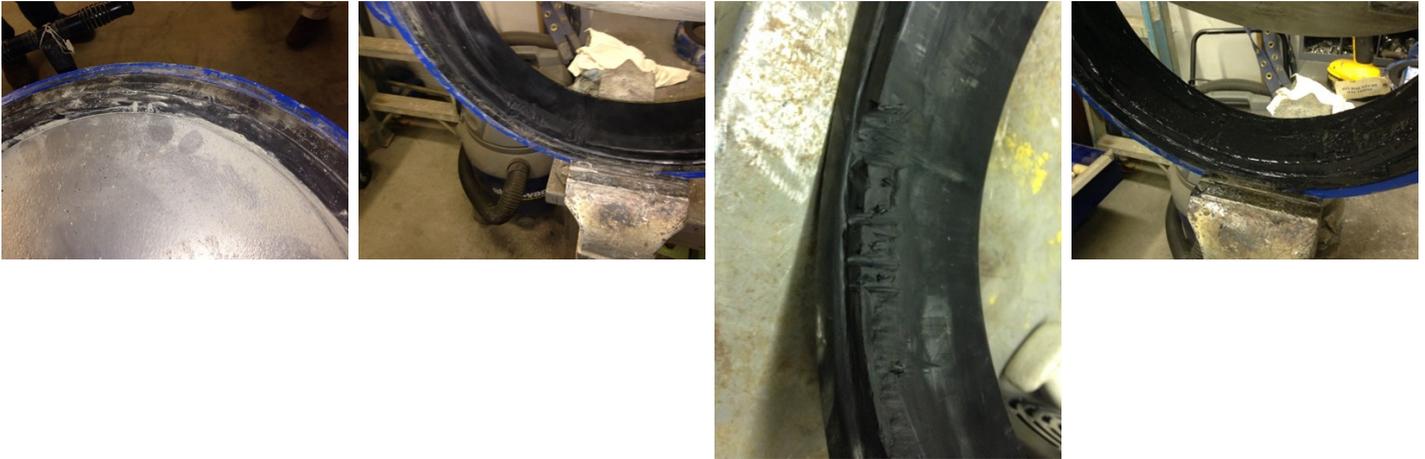
The customer uses a cyclone and piping to move cement from barges to silos. Eroded areas at the edge of the valve flappers were allowing small amounts of cement and air to escape around the edges and further eroding the natural rubber.

- \* Erosion around the edges of the flapper ,
- \* Erosion more obvious with flapper removed ,
- \* Substrate cleaned and roughened, ready for conditioning ,
- \* Completed application, ready to go back into service ,

The application was carried out in accordance with Belzona Know-How System Leaflet VPF-1. The substrate was cleaned and roughened using a wire brush and a razor. The effect of the razor was to make dovetail like mechanical bonds. Belzona 2911 was used to condition the surface and allowed to dry for 30 minutes. The surface profile was rebuilt with Belzona 2311 using a Belzona applicator. Alternatively, a release agent could have been used on the flapper and the flapper could have been closed onto the still

wet Belzona 2311 to create a perfect seal.
