# BELZONA CALLED IN FOR TOUGH FLOOR REPAIRS

ID: 5942

**Industry:** Buildings & Structures  
**Application:** FPA-Floor Problem Areas  
**Substrate:** Concrete  
**Products:** \* Belzona 4111 (Magma-Quartz) ,  
\* Belzona 4911 (Magma TX Conditioner) ,

**Customer Location:** Clarksville, TN, USA  
**Application Date:** September 2015

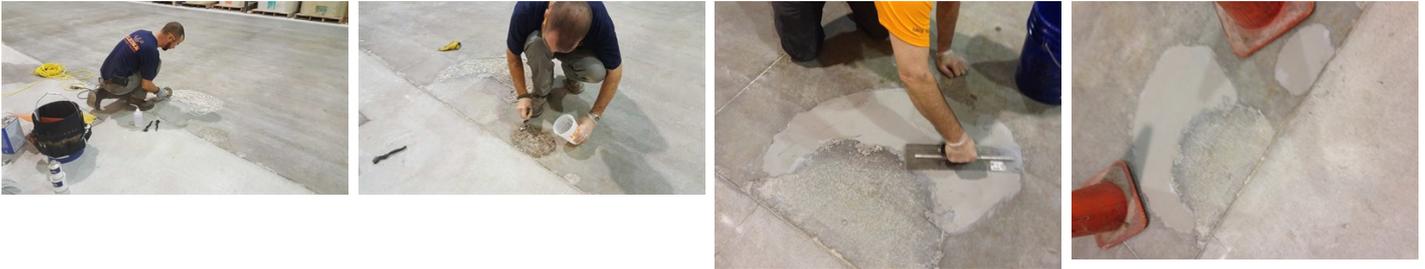
## Photograph Descriptions

## Problem

- \* Preparing the area with a grinder ,
- \* Conditioning with Belzona 4911 ,
- \* Applying Belzona 4111 by trowel ,
- \* Completed application ,

The application was carried out in accordance with Belzona Know-How System Leaflet FPA-1. The repair area was cleaned using acetone and a rotary wire wheel. An angle grinder was then used with a masonry wheel to prepare the area to allow for an application of at least 1/4" of Belzona 4111. The area was then given a final cleaning with acetone. Belzona 4911 was used to condition the substrate and Belzona 4111 was then trowelled into place and smoothed out. In the warm environment the repair was ready for service in about 4 hours.
