# BELZONA CALLED IN FOR TOUGH FLOOR REPAIRS

ID: 5942

**Industry:** Buildings & Structures  
**Application:** FPA-Floor Problem Areas  
**Substrate:** Concrete  
**Products:** \* Belzona 4111 (Magma-Quartz) ,  
\* Belzona 4911 (Magma TX Conditioner) ,

**Customer Location:** Clarksville, TN, USA  
**Application Date:** September 2015

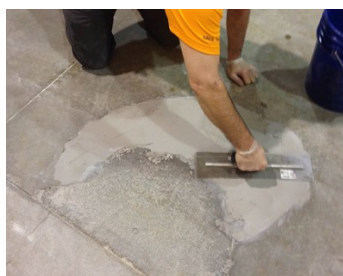
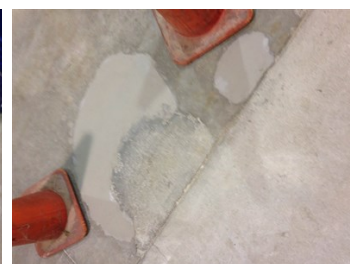
- \* Preparing the area with a grinder ,
- \* Conditioning with Belzona 4911 ,
- \* Applying Belzona 4111 by trowel ,
- \* Completed application ,

The application was carried out in accordance with Belzona Know-How System Leaflet FPA-1. The repair area was cleaned using acetone and a rotary wire wheel. An angle grinder was then used with a masonry wheel to prepare the area to allow for an application of at least 1/4" of Belzona 4111. The area was then given a final cleaning with acetone. Belzona 4911 was used to condition the substrate and Belzona 4111 was then trowelled into place and smoothed out. In the warm environment the repair was ready for service in about 4 hours.
