# BELZONA STOPS LIVE AIR HANDLER LEAK

ID: 5943

**Customer Location:** Hospital, Nashville, TN, USA  
**Application Date:** September 2015

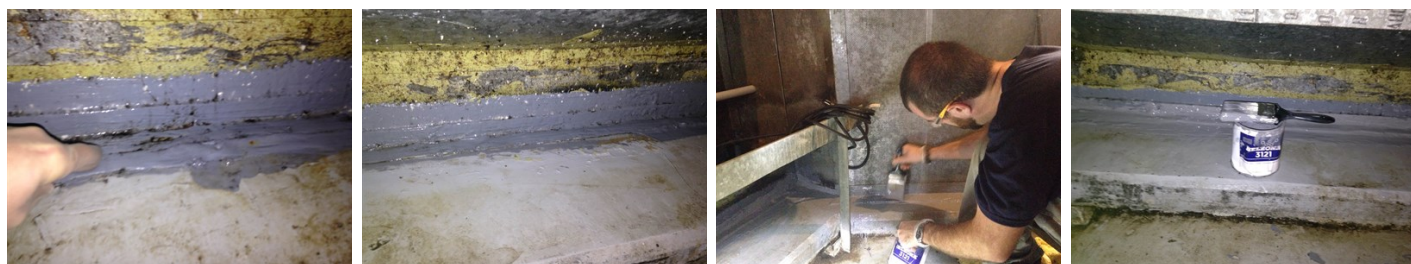
The air handler condensate pan was leaking water. Corrosion had allowed for water to push underneath the pan and out between the pan and concrete pedestal. This was the result of a previously applied competitor's coating in the pan and around the bottom seam disbonding.

- \* Old coating disbonded, notice the bubble pushing through when the material was pressed on ,
- \* Bad portion of old coating removed, prepped with wire brush and wiped with acetone ,
- \* Application of Belzona 3121 in progress ,
- \* Completed application ,

The application was carried out in accordance with a modified version of Belzona Know-How System Leaflet RPA-1. The areas in which the competitors coating had failed were scraped and cut away and the surface was cleaned using a reciprocating wire brush and acetone. The area was dried as well as possible but water was still escaping from under the pan and across the area to be repaired. Because of the presence of water, Belzona 3121 was chosen for it's surface tolerant properties. The joint where the water was leaking between the pan and the pedestal was then coated with Belzona 3121 to stop the water. The first application stopped most of the water but a second application/overcoat was needed to finalize it.
