Belzona Renews Black Water Tank

Industry: Marine
Application: SOS-Ships and Offshore Structures

Customer Location: Fort Lauderdale, Florida
Application Date: July 2005

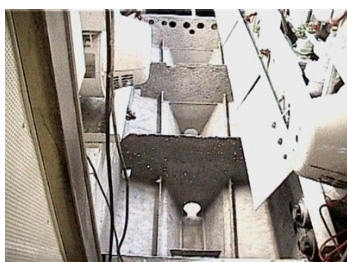
Severe pitting caused by H₂S attack of aluminum walls, top and supports causing leakage of sewage to bilge.

- * My Absolute at Cable Marine, Ft. Lauderdale, Florida ,
- * Severe pitting wastage of tank walls and supports ,
- * Doubler plates and Belzona® 1121 applied ,
- * Final protection with Belzona® 5811 awaiting top ,
