# Belzona repairs porcelain shed

**Industry:** Power  
**Application:** VPF-Valves, Pipes and Fittings  
**Substrate:** Porcelain  
**Products:** \* Belzona 1111 (Supermetal) ,  
\* Belzona 4311 (Magma CR1) ,  
\* Belzona 2211 (MP Hi-build Elastomer) ,

**Customer Location:** Sub Station Herefordshire, UK  
**Application Date:** September 2015

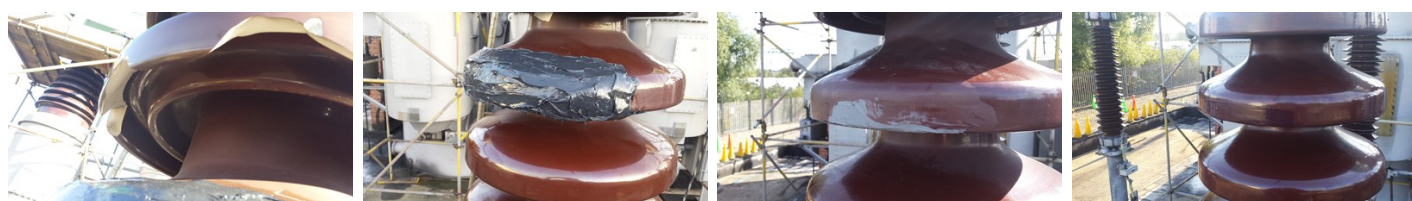
- \* 1. The damaged shed ,
- \* 2. The Elastomer applied to create the mold ,
- \* 3. The repair before coating ,
- \* 4. The finished repair with Belzona 4311 applied ,

The sub station had a recent outage for routine repairs. During the outage a contractor accidentally damaged one of the porcelain sheds breaking off and cracking parts of the porcelain.

A mould of a sound area of the shed was created by applying Belzona 2211 after treating substrate with Belzona 9411 (Release Agent). Once the Elastomer mould had cured it was removed, Belzona 9411 applied inside before wetting out the damaged portion of the shed with Belzona 1111. More Belzona 1111 was applied to the damaged area of the shed before the mould was positioned to rebuild the shed profile. Once Belzona 1111 had cured the mould was removed and a coat of Belzona 4311 was applied over the repair to colour match and to prevent arcing across the repair.
