# BELZONA BONDS CABLE TRAY ON FPSO

ID: 5967

Customer Location: South Korea  
Application Date: May, 2006

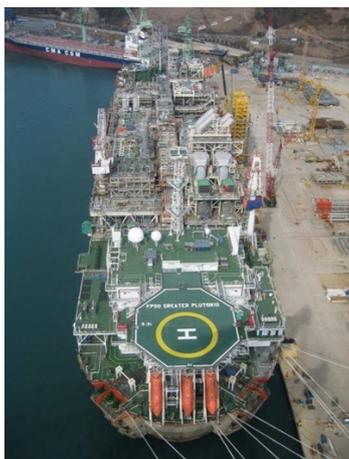
After the FPSO was painted, it was discovered that a cable tray had not been welded onto the deck. Welding would damage the paintwork, therefore Belzona was approached for a cold applied solution.

- \* 1. View of the vessel from above ,
- \* 2. View of the bonding application ,

The application was carried out in accordance with a modified version of Belzona Know-How System Leaflet GSS-9.

In order to ensure that Belzona solution can be used for this application, a test has been performed mimicking expected in-service conditions. Result - test sample withstood 19.4kN of loading. Prequalification information and excellent vendor support have enabled the client to make the easy decision of using a Belzona solution. This bonding application has been in service with no issues since 2006.
