# BELZONA 7111 ACCURATELY LOCATES EXCAVATOR BEARING SEAT

Industry: *Mining & Quarrying*  
Application: *GSS-Gaskets, Seals and Shims*  
Substrate: *Carbon Steel*  
Products: *\* Belzona 7111 ,*

Customer Location: *Mining Company, Germany*  
Application Date: *August 2015*

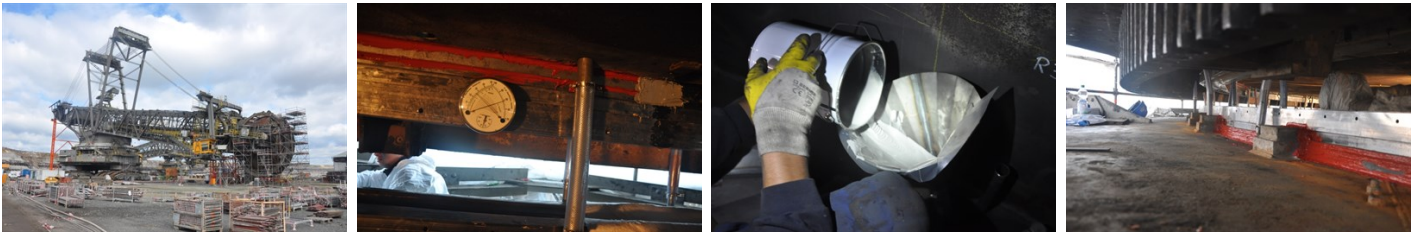
## Photograph Descriptions

- \* The Excavator ,
- \* Measuring substrate temperature ,
- \* Pouring Belzona 7111 ,
- \* View of the secured bearing seat ,

The application was carried out in accordance with Belzona Know-How System Leaflet GSS-12. 1750 Kg of Belzona 7111 was poured to accurately locate the bearing seat.
