# BELZONA REPAIRS WASTEWATER PUMPS

ID: 598

Industry: Fluid Flow  
Application: CEP-Centrifugal Pumps  
Substrate: Cast iron  
Products: \* Belzona® 1341 (Supermetalgilde) ,

Customer Location: Large wastewater station, Egypt  
Application Date: October 2000

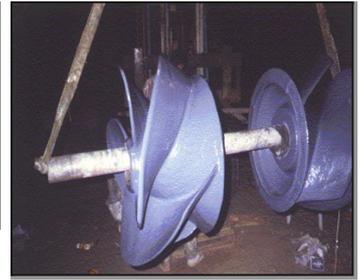
Corroded diffuser, casings and impellers leading to low efficiency of the pumps.

- \* Corroded casings ,
- \* Corroded diffuser ,
- \* Diffuser was coated ,
- \* Impeller coating completed ,

Application was carried out in accordance with Belzona Know-How System Leaflet CEP-3.

A total of five pumps were repaired saving \$700,000 - the price of new pumps. The pumps are still operating efficiently five years on. The pumps efficiency was raised 8% over the original performance.
