BELZONA REPAIRS WASTEWATER PUMPS

Industry: *Fluid Flow*
Application: *CEP-Centrifugal Pumps*
Substrate: *Cast iron*
Products: ** Belzona® 1341 (Supermetalgilde) ,*

Customer Location: *Large wastewater station, Egypt*
Application Date: *October 2000*

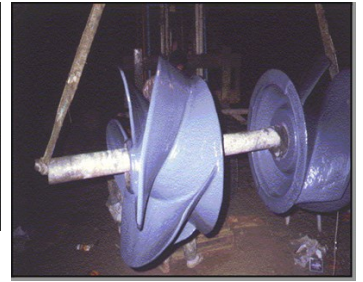
Corroded diffuser, casings and impellers leading to low efficiency of the pumps.

- * Corroded casings ,
- * Corroded diffuser ,
- * Diffuser was coated ,
- * Impeller coating completed ,

Application was carried out in accordance with Belzona Know-How System Leaflet CEP-3.

A total of five pumps were repaired saving \$700,000 - the price of new pumps. The pumps are still operating efficiently five years on. The pumps efficiency was raised 8% over the original performance.
