BELZONA PROTECTS NEW PROCESS VESSELS FOR NATURAL GAS PURIFICATION PLANT

Industry: Oil & Gas
Application: TCC-Tanks and Chemical Containment Areas
Substrate: Carbon steel
Products: * Belzona 1321 (Ceramic S-Metal) ,
* Belzona 1391T ,
* Belzona 1591 (Ceramic XHT) ,

Customer Location: Major Oil and Gas Customer, China
Application Date: August 2014

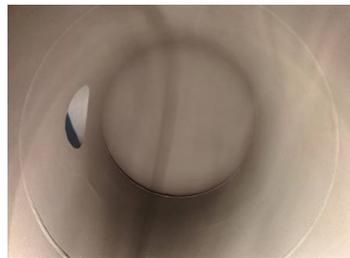
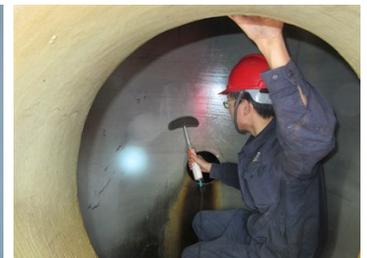
- * Overview of some vessels ,
- * Overview of interior of the vessels after blasting ,
- * Application completed and inspected ,
- * After 1 year in service, the re-inspection showed a "flawless" lining ,

The application was carried out in accordance with Belzona Know-How System Leaflet TCC-5.

The Belzona internal linings have been a cost effective solution, protecting the vessels from aggressive erosion and corrosion, while ensuring the plant operated safely. The application team was well trained by Belzona and strictly implemented the Belzona global application standard which enabled the application to be delivered to a high standard. After immersed in aggressive media such as acid solvent, sour gas and sediment for 1 year, when the vessels were inspected on-site, the internal lining showed no signs of deterioration.
