BELZONA PROTECTS NEW PROCESS VESSELS FOR NATURAL GAS PURIFICATION PLANT

Industry: Oil & Gas
Application: TCC-Tanks and Chemical Containment Areas
Substrate: Carbon steel
Products: * Belzona 1321 (Ceramic S-Metal) ,
* Belzona 1391T ,
* Belzona 1591 (Ceramic XHT) ,

Customer Location: Major Oil and Gas Customer, China
Application Date: August 2014

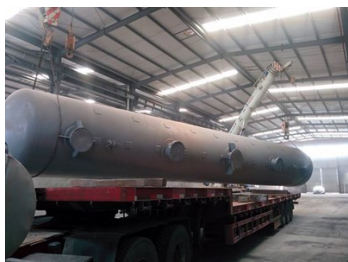
- * Overview of some vessels ,
- * Overview of interior of the vessels after blasting ,
- * Application completed and inspected ,
- * After 1 year in service, the re-inspection showed a "flawless" lining ,
