# BELZONA PROTECTS NEW PROCESS VESSELS FOR NATURAL GAS PURIFICATION PLANT

ID: 5985

Customer Location: Major Oil and Gas Customer, China  
Application Date: August 2014

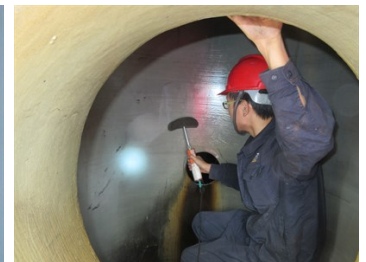
- \* Overview of some vessels ,
- \* Overview of interior of the vessels after blasting ,
- \* Application completed and inspected ,
- \* After 1 year in service, the re-inspection showed a "flawless" lining ,

The Belzona internal linings have been a cost effective solution, protecting the vessels from aggressive erosion and corrosion, while ensuring the plant operated safely. The application team was well trained by Belzona and strictly implemented the Belzona global application standard which enabled the application to be delivered to a high standard. After immersed in aggressive media such as acid solvent, sour gas and sediment for 1 year, when the vessels were inspected on-site, the internal lining showed no signs of deterioration.
