Belzona repairs damaged floor in a warehouse

Customer Location: Cement plant in Croatia

Application: FPA-Floor Problem Areas

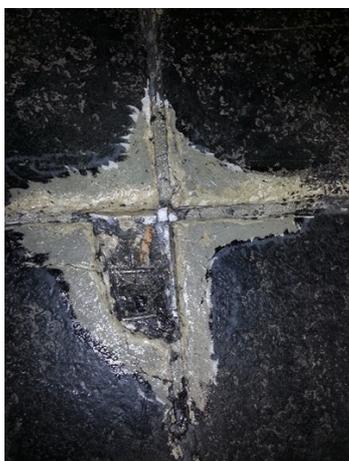
View of application area

Concrete floor of a warehouse in a cement plant was damaged due to heavy traffic of forklifts and trucks, as well as storage of palettes with cement over time. The damage was situated on joint areas of large concrete plates (3m x 5m) of the floor.

The application was carried out in accordance with Belzona Know-How System Leaflet FPA-1 and FPA-6.

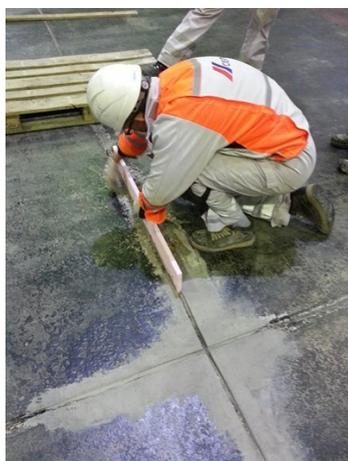
Application in progress

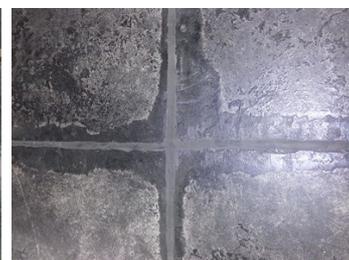
Situation after 8 years in service.

Because of continuous 24/7 production, the warehouse must be in use all the time and only small portion of it could be out of use. According to customer, Belzona offered the best value for money, allowing the customer's staff to do repairs themselves in periods with less activity in the warehouse. Site revisited after 1 year shows that repaired area is still in perfect shape.
