# BELZONA GIVES NEW LIFE TO ALMOST SCRAPPED PUMPS

**Industry:** Steel & Metal Processing  
**Application:** CEP-Centrifugal Pumps  
**Substrate:** White Cast Iron  
**Products:** \* Belzona 1311 (Ceramic R-Metal) ,  
\* Belzona 1341 (Supermetalgilde) ,

**Customer Location:** Copper Processing Plant, Bulgaria  
**Application Date:** March, 2015

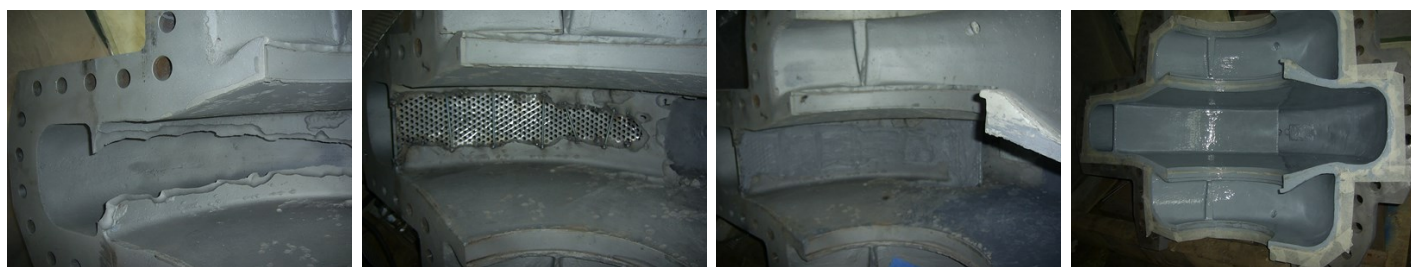
Due to many years of service exposed to erosion and corrosion effects, the housings and covers of two pumps had significant wear, particularly at cutwaters, flow straighteners and wear ring seats. The pumps had been decommissioned and considered as scrap before the Distributor proposal for recovery with products and technologies of Belzona.

- \* After blasting the pumps' wear clearly visible ,
- \* Reinforcing framework to cutwater ,
- \* Rebuilding with Belzona 1311 ,
- \* Completed application with two coats of Belzona 1341 ,

The application was carried out in accordance with Belzona Know-How System Leaflets CEP-1, CEP-2 and CEP-3. The pump surface was prepared by blasting, severe damages and missed edges required reinforcing the steel framework with the application of Belzona 1311 to restore original profile. Forming technique was used for wear ring seats and gland housings. After whole case and cover recovery and flash blasting, two coats of Belzona 1341 were applied.
