RECOVERY AND PROTECTION OF OLD HEAT EXCHANGER WITH BELZONA

ID: 5994

Application: HEX-Heat Exchangers

Customer Location: Oil Refinery, Bulgaria

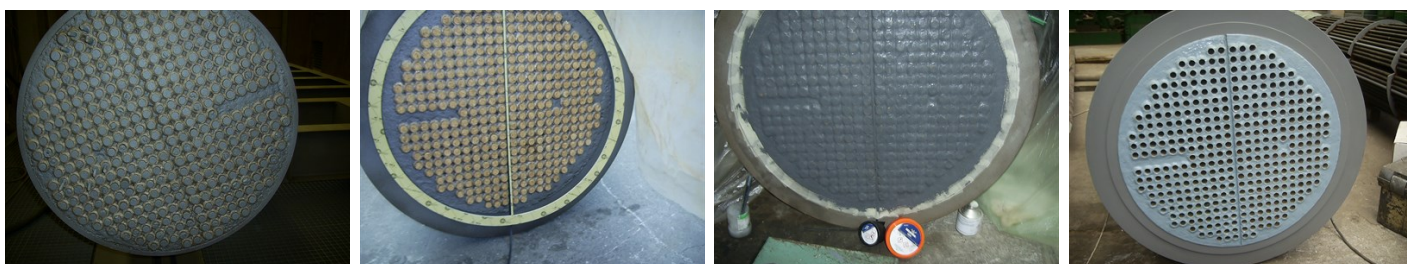
Photograph Descriptions

Surface of the tube sheets were badly corroded and required recovery and protection to stop unwanted leakages.

- * Grid blasted plate ,
- * Formers and cork plugs used to limit the repair area ,
- * Corroded areas rebuilt with Belzona ,
- * Application completed after 2 coats of Belzona 1391T and cork plugs pulled out ,

The application was carried out in accordance with Belzona Know-How System Leaflets HEX-1 and HEX-3. After grit blasting, erosion damage was rebuilt before applying Belzona 1391T for overall corrosion protection. A special flange shaped former was coated with Belzona 9411 and positioned so the flange remained uncoated.
