# TRAIN BAGGAGE CAR SEALED AND PROTECTED WITH BELZONA

ID: 5999

Industry: Transport  
Application: WPA-Wall Problem Areas  
Substrate: Carbon Steel  
Products: \* Belzona 2911 (Elastomer QD Conditioner) ,  
\* Belzona 2211 (MP HI-Build Elastomer) ,  
\* ,

Customer Location: Railroad Company, Montana, USA  
Application Date: 2004

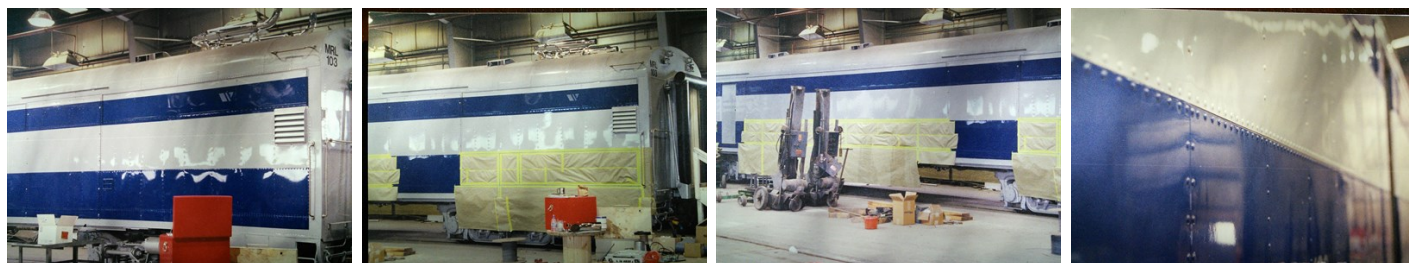
Leaks on a riveted/stitch-welded seam. Since the car had already been painted and finished on the exterior, a cold process needed to be used to save the decorative paint. Also, the car needed a flexible seal to accommodate the movement while traveling. With the expense already invested, a long term solution needed to be found that would stay flexible and withstand the elements in extreme weather.

- \* Generator/Baggage car in a car shop ,
- \* Surface preparation underway ,
- \* Full length of joint being applied ,
- \* Finished joint looks very aesthetic ,

The application was carried out in accordance with a modified version of Belzona Know-How System Leaflet WPA-3 and Belzona 2211 Instructions For Use.

Belzona 2211 allowed the applicators to install the material without damage to the finished surfaces inside and outside of the wall. Belzona 2211 is a paste grade material for rebuilding up to 0.5 in thickness without slump, allowing the application to be performed on a vertical wall without forming techniques. Belzona 2211 is also a long term solution that will hold up to the outdoor conditions and weather, preventing damage later as well as numerous re-applications.
