TRAIN BAGGAGE CAR SEALED AND PROTECTED WITH BELZONA

ID: 5999

Customer Location: *Railroad Company, Montana, USA*
Application Date: *2004*

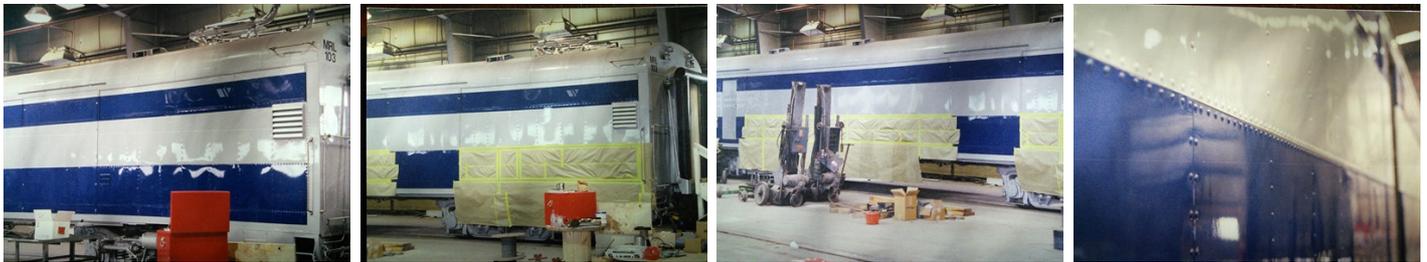
Photograph Descriptions

Leaks on a riveted/stitch-welded seam. Since the car had already been painted and finished on the exterior, a cold process needed to be used to save the decorative paint. Also, the car needed a flexible seal to accommodate the movement while traveling. With the expense already invested, a long term solution needed to be found that would stay flexible and withstand the elements in extreme weather.

- * Generator/Baggage car in a car shop ,
- * Surface preparation underway ,
- * Full length of joint being applied ,
- * Finished joint looks very aesthetic ,

The application was carried out in accordance with a modified version of Belzona Know-How System Leaflet WPA-3 and Belzona 2211 Instructions For Use.

Belzona 2211 allowed the applicators to install the material without damage to the finished surfaces inside and outside of the wall. Belzona 2211 is a paste grade material for rebuilding up to 0.5 in thickness without slump, allowing the application to be performed on a vertical wall without forming techniques. Belzona 2211 is also a long term solution that will hold up to the outdoor conditions and weather, preventing damage later as well as numerous re-applications.
