BELZONA CONTAINMENT AREA REBUILT AND PROTECTED

Industry: Power
Application: TCC-Tanks and Chemical Containment Areas
Substrate: Concrete
Products: * Belzona® 4111 (Magma Quartz) ,
* Belzona® 4141 (Magma Build) ,
* Belzona® 4311 (Magma CRI) ,

Customer Location: Power plant in Illinois
Application Date: October 1995

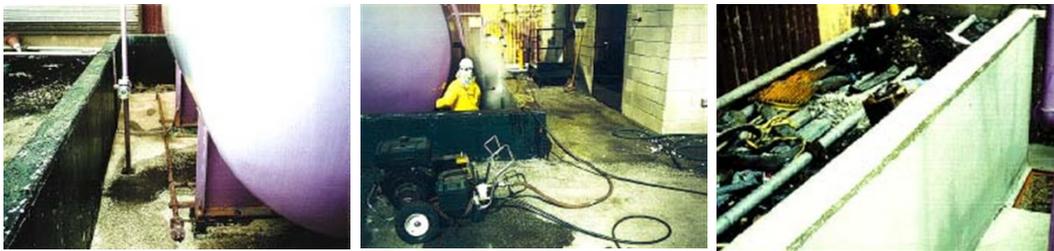
Concrete attacked by acid

- * Concrete degraded, old coating failed. ,
- * Surface preparation, first power washing, followed by grit blasting. ,
- * Floors rebuilt with Belzona® 4111, walls rebuilt with Belzona® 4141, brush blasted and then overcoated with Belzona® 4311 for resistance to sulfuric acid 0-98%. ,

Sulfuric acid chemical containment area

The application was carried out in accordance with Belzona Know-How Leaflets TCC-9 and TCC-15.

All previous coatings failed. The application was recently inspected and found to be in excellent condition after 2 years.
