# BELZONA CHILLER PROTECTION

**Industry:** Heating, Ventilation & Air Conditioning  
**Application:** HEX-Heat Exchangers  
**Substrate:** Steel  
**Products:** \* Belzona® 1341 (Supermetalgilde) ,

**Customer Location:** Five star hotel in Egypt  
**Application Date:** April 2005

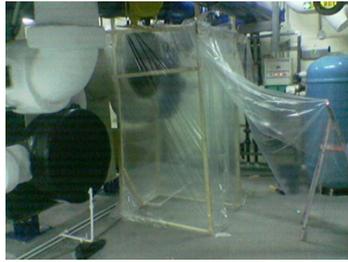
*Corrosion of the tube sheet and water box.*

- \* The corroded water box ,
- \* Surface preparation ,
- \* Tube sheet completed ,
- \* Water box completed ,

Application was carried out in accordance with Belzona Know-How System Leaflet HEX-3.
