# WICKET GATES REPAIRED WITH BELZONA

Industry: Power  
Application: VPF-Valves, Pipes and Fittings  
Substrate: Steel  
Products: \* Belzona 1311 (Ceramic R-Metal) ,  
\* Belzona 1321 (Ceramic S-Metal) ,  
\* Belzona 9111 (Cleaner/Degreaser) ,

Customer Location: Montana, USA  
Application Date: 2000

Wicket gates at a hydroelectric power station.

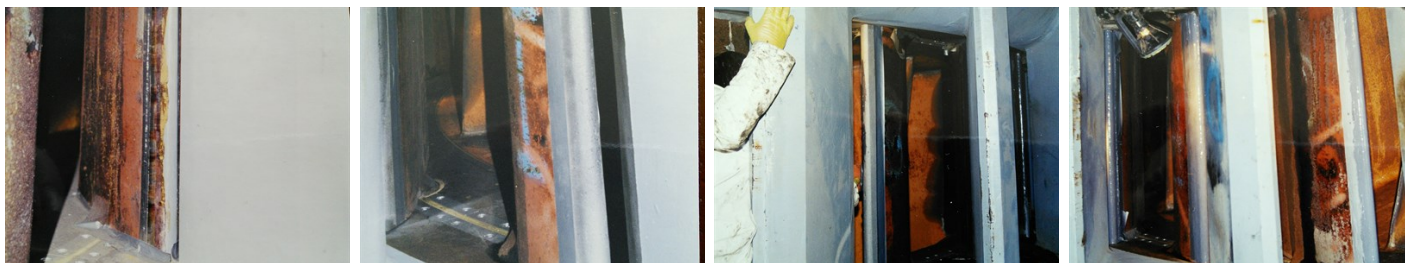
## Photograph Descriptions

Surface preparation of a previous application was inadequate for the repair of these wicket gates. The coating was failing due to poor adhesion to an improperly prepared surface. Constant erosion and corrosion of these wicket gates caused repeated applications from time to time, but the service times were becoming too frequent in comparison to previous performance.

- \* Poor surface preparation caused coating to fail ,
- \* Surface properly prepared ,
- \* Application of Belzona 1321 ,
- \* Three wicket gates coated ,

The application was carried out in accordance with a modified version of Belzona Know-How System Leaflet VPF-1, VPF-2, and Belzona Instructions For Use.
