# BELZONA REPAIRS PRESS PLATEN AND SAVES REVENUE LOSSES

ID: 6005

Customer Location: Montana, USA  
Application Date: 2004

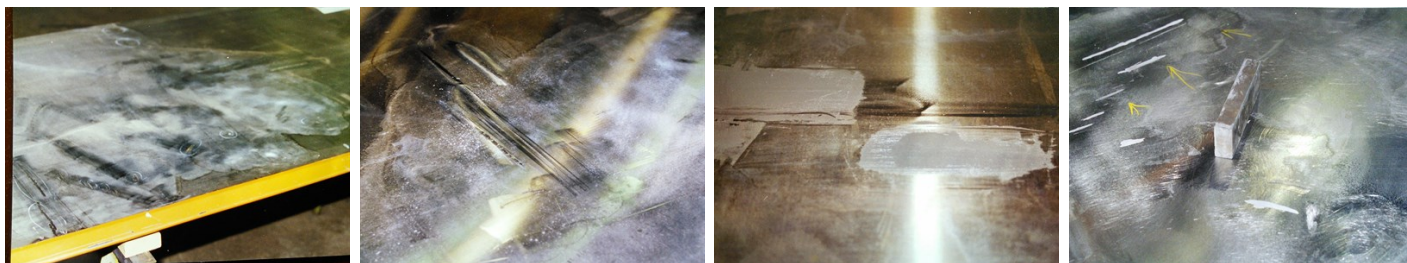
## Photograph Descriptions

Damaged platen on the press of this particle board manufacturer was causing culled product. Particle board quality was not meeting standards due to the damage of the platen surface. The surface needs to be flat and smooth and the repair material must be machinable and withstand high temperatures of the steam heated platen. Quality control of this particle board manufacturer is very high and would not allow the defects that the damaged platen produced. All the effort and costs of process up to the point of the press in this manufacturing process was wasted when this platen was used. The wall thickness of the steam platen would deform if arc welding was performed to repair the damage.

- \* Damaged steam platen surface ,
- \* Surface of platen prepared ,
- \* Belzona 1111 applied and curing ,
- \* Smooth surface of platen restored ,

The application was carried out in accordance with a modified Belzona Know-How System Leaflet ENC-7 and Belzona Instructions For Use.

The use of a paste grade cold curing product such as Belzona 1111 prevented the scrapping of this expensive piece of equipment. This repair put the platen ready to go back in service, and saved the waste of raw product and man hours of sorting and disposal of particle board.
