# INDUSTRIAL WASTEWATER IMPELLERS REPAIR

ID: 601

Industry: Water / Wastewater  
Application: CEP-Centrifugal Pumps  
Substrate: Cast iron  
Products: \* Belzona® 2111 (D&A Hi-Build Elastomer) ,  
\* Belzona® 2121 (D&A Hi-Coat Elastomer) ,

Customer Location: Industrial wastewater plant, Egypt  
Application Date: April 2003

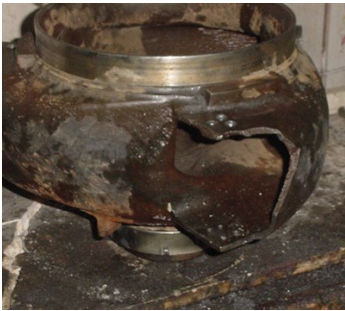
The edges of impellers were broken due to impact, abrasion and corrosion.

- \* The broken edges of the impellers ,
- \* Steel sheets inserted to form the leading edges ,
- \* Edges were formed by Belzona® 2111 ,
- \* Final application, coated by Belzona® 2121 ,
