# BELZONA REPAIRS NATURAL GAS VALVE

ID: 602

Industry: Oil & Gas  
Application: VPF-Valves, Pipes and Fittings  
Substrate: Cast iron  
Products: \* Belzona® 1111 (Super Metal) ,

Customer Location: Oil and gas production company, Egypt  
Application Date: February 2003

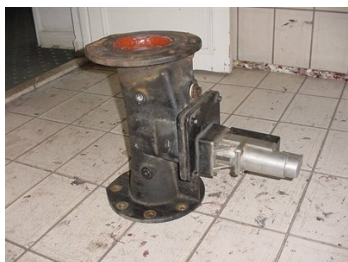
Gas leaks had been worsened by traditional weld repairs.

- \* General view of the valve ,
- \* Traditional welding failed causing more leakage ,
- \* Surface preparation ,
- \* Application completed ,

Natural gas valve

Application was carried out in accordance with Belzona Know-How System Leaflet VPF-1.

Belzona successfully solved this serious problem with a simple and fast technique, avoiding heat distortion to the surface and at a low cost.
