BELZONA REPAIRS NATURAL GAS VALVE

Industry: Oil & Gas
Application: VPF-Valves, Pipes and Fittings
Substrate: Cast iron
Products: * Belzona® 1111 (Super Metal) ,

Customer Location: Oil and gas production company, Egypt
Application Date: February 2003

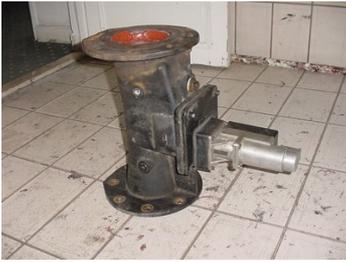
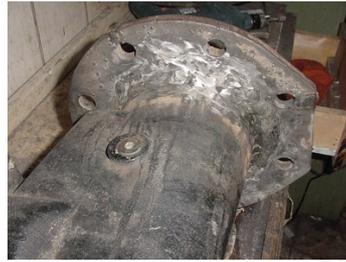
Gas leaks had been worsened by traditional weld repairs.

- * General view of the valve ,
- * Traditional welding failed causing more leakage ,
- * Surface preparation ,
- * Application completed ,

Application was carried out in accordance with Belzona Know-How System Leaflet VPF-1.

Belzona successfully solved this serious problem with a simple and fast technique, avoiding heat distortion to the surface and at a low cost.
