BELZONA 5811 INJECTION PREVENTS NOZZLE CORROSION

ID: 6021

Customer Location: Gulf of Mexico, USA
Application Date: 2016

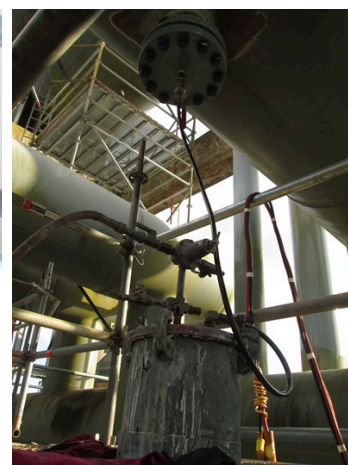
"Dog Leg" nozzles ranging from 2" - 4" were suffering severe corrosion and wall loss due to condensate build-up in the nozzle and lack of draining or cleaning.

- * Encapsulation nozzle with blind flange bolted on. ,
- * Cut off old nozzle encapsulated by new nozzle. ,
- * Belzona 1121 used to fill void prior to injection. ,
- * Belzona 5811 injection in progress. ,

Old corroded nozzles were cut off and new encapsulation nozzles of a larger diameter were welded on around the stub from the old cut-off nozzle. Belzona 1121 was used to fill in the void between the old stub and the new encapsulation wall (where an air pocket would have formed). A blind flange tapped for a 3/4 inch hose was then secured to the new encapsulation nozzle. The blind flange had a 3/4 inch hose and ball valve which was connected to a paint pot. The correct calculated volume of Belzona 5811 was then

mixed and set into the paint pot, and air pressure was applied to inject the Belzona 5811 into the encapsulation nozzle. The hose was quickly swapped out for a threaded plug, and the whole encapsulation was wrapped in heat trace elements. After a one hour set up at ambient temperature, the encapsulation was brought to 175°F over a 4 hour period, and then held for two hours to ensure full mechanical cure.
