BELZONA ELIMINATES MATING SURFACE CORROSION

Industry: *Marine*
Application: *GSS-Gaskets, Seals and Shims*
Substrate: *Carbon steel*
Products: *Belzona 1161 (Super UW-Metal), Belzona 5831 (ST-Barrier)*

Customer Location: *Naples, Italy*
Application Date: *February 2016*

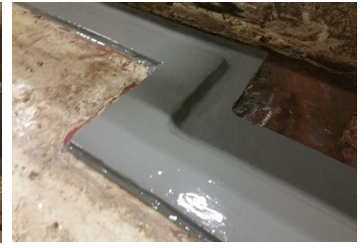
Belzona 1161 used to rebuild the damaged area

The application was carried out in accordance with Belzona Know-How System Leaflet GSS-8. Surface preparation was carried out by grinding. The pitted and eroded areas were rebuilt using Belzona 1161. The plates were then protected with a coat of Belzona 5831.
