# SEAWATER FIRE PUMP REPAIR WITH BELZONA

ID: 6033

Customer Location: Houston, TX, USA  
Application Date: March 2012

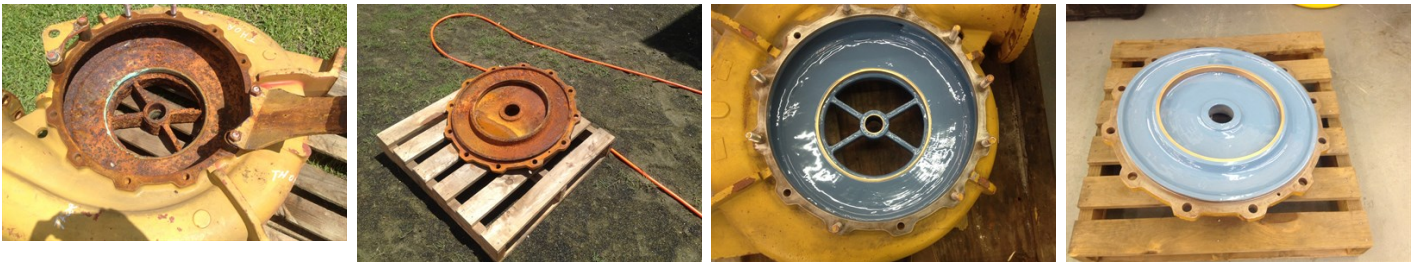
The customer was having problems with severe corrosion on the pumps due to them being idle for months at a time, often after only a few years of use they were being replaced with new ones.

- \* Severely corroded pump ,
- \* Corroded pump end-cover ,
- \* Pump after the application ,
- \* Pump end-cover after the application ,

The application was carried out in accordance with a modified version of Belzona Know-How System Leaflet CEP-3.

For a fraction of the cost of a new pump the customer is now having his pumps repaired with Belzona products. This not only offers significant savings, but the coated pumps last in service 3 times longer than the originals.
