Belzona Saves the Alignment of the Pump and Motor

ID: 6038

Metal Pump Base

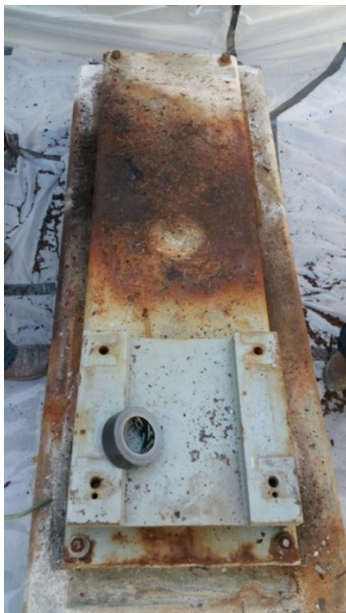
The occasional leaking seal of process water was causing the advanced corrosion attack of the metal substrate of the pump base, which was leading up to the possibility of the base collapsing. At which point the pump and motor would be out of alignment.

- * 1. Corroded pump base ,
- * 2. Pump base blasted and Belzona 1121 being applied ,
- * 3. Belzona 5811 applied to pump base ,
- * 4. Belzona 5233 applied as a top coat. ,
