BELZONA STOPS LEAKS AND PROTECTS PARKED CARS

ID: 6043

Customer Location: Houston, TX, USA
Application Date: December 2015

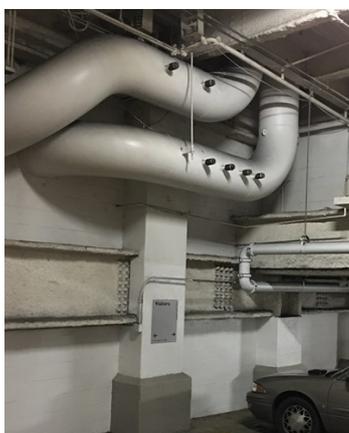
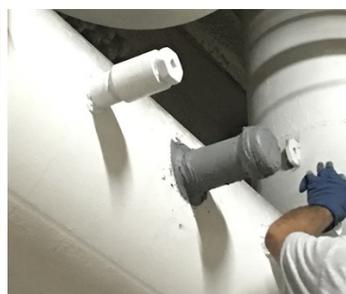
Photograph Descriptions

Cooling tower line drains were leaking and causing damage to the paint of vehicles parked below. Aesthetics were important to the client. Not only did they need the leak stopped, they also needed a solution that would not be an eye-sore to their tenants.

- * Before Application ,
- * After surface preparation ,
- * Belzona 1161 used to apply cap to leaking area ,
- * Complete project with Belzona 5111 used to match the existing paint on the line ,

The application was carried out with a modified version of Belzona Know-How System Leaflet VPF-15.

The Belzona application was carried out in half a day and the customer was in service during the repair. Alternative methods would have taken the cooling tower offline for 2-3 days, leaving tenants uncomfortable and the cost much more expensive.
