# BELZONA STOPS LEAKS AND PROTECTS PARKED CARS

**Industry:** Buildings & Structures  
**Application:** VPF-Valves, Pipes and Fittings  
**Substrate:** Carbon Steel  
**Products:** \* Belzona 1161 (Super UW-Metal) ,  
\* Belzona 5111 (Ceramic Cladding) ,

**Customer Location:** Houston, TX, USA  
**Application Date:** December 2015

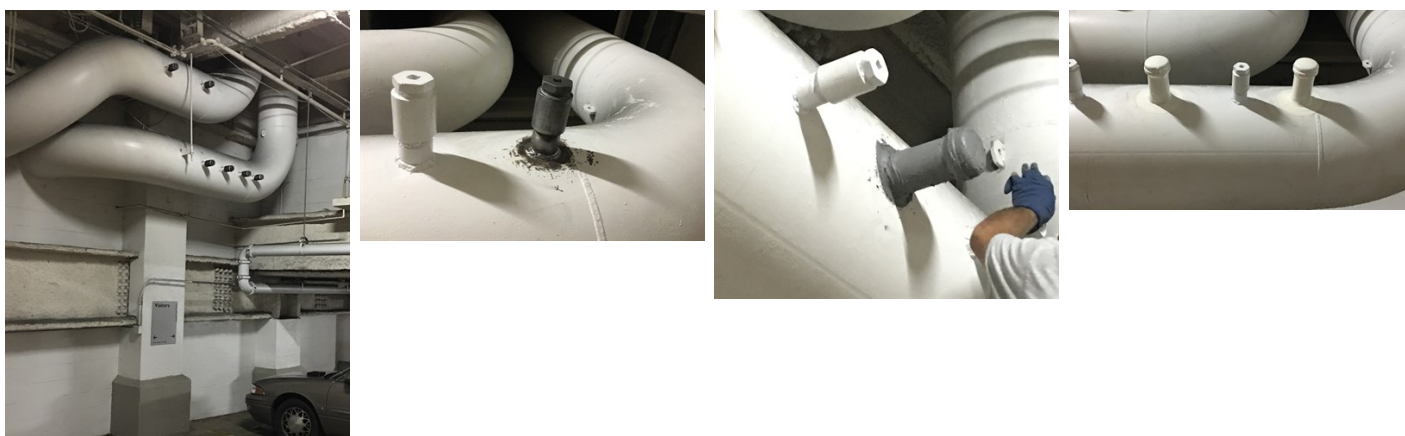
Cooling tower line drains were leaking and causing damage to the paint of vehicles parked below. Aesthetics were important to the client. Not only did they need the leak stopped, they also needed a solution that would not be an eye-sore to their tenants.

- \* Before Application ,
- \* After surface preparation ,
- \* Belzona 1161 used to apply cap to leaking area ,
- \* Complete project with Belzona 5111 used to match the existing paint on the line ,

The application was carried out with a modified version of Belzona Know-How System Leaflet VPF-15.

The Belzona application was carried out in half a day and the customer was in service during the repair. Alternative methods would have taken the cooling tower offline for 2-3 days, leaving tenants uncomfortable and the cost much more expensive.
