BELZONA REBUILDS CLARIFIER RUNNING TRACK

ID: 605

Customer Location: Sewage farm - Switzerland
Application Date: 2003

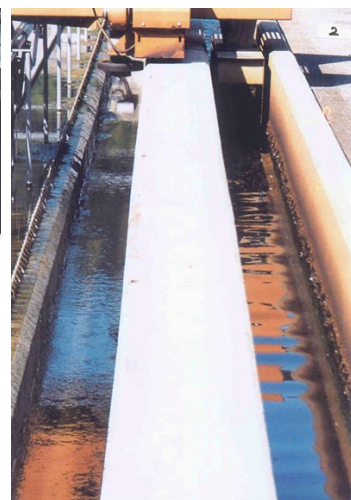
The wheels had caused between 2mm and 10mm wear to the concrete and were not running smoothly.

- * The clarifier track ,
- * Conditioning the surface with Belzona® 4911 ,
- * Rebuilding with Belzona® 4111 ,
- * The finished track ,

The track was rebuilt with Belzona® 4111 in accordance with Belzona Know-How System Leaflet FPA-1.
