# BELZONA REPAIRS REFINERY BOILER ROOM ROOF

**Industry:** Chemical & Petrochemical  
**Application:** RPA-Roof Problem Areas  
**Substrate:** Concrete and Galvanised Iron Sheet  
**Products:** \* Belzona 4111 (Magma Quartz),  
\* Belzona 3111 (Flexible Membrane),

**Customer Location:** Oil & Gas Company, Saudi Arabia  
**Application Date:** February 2010

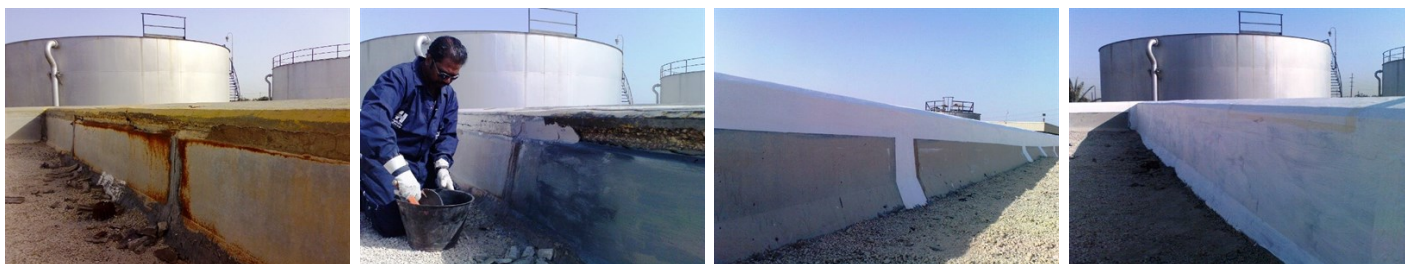
Spalled concrete on the parapet side of the roof allowed water ingress that resulted in flooding inside the Boiler Room.

\* 1. View of damaged parapet wall 2. Concrete repair using Belzona 4111 3. View of completed application including Belzona 3111 waterproofing protection 4. View after 12 months of exposure to the local environmental conditions ,

Application was carried out in accordance with Belzona Know-How System Leaflets RPA-9, RPA-10 & RPA-11. Spalled concrete was rebuilt with Belzona 4111 before waterproofing area with Belzona 3111 system.
