# BELZONA PROVIDES LONG-TERM SOLUTION FOR SPALLED CONCRETE

Application: WPA-Wall Problem Areas

Customer Location: School, Essex, UK

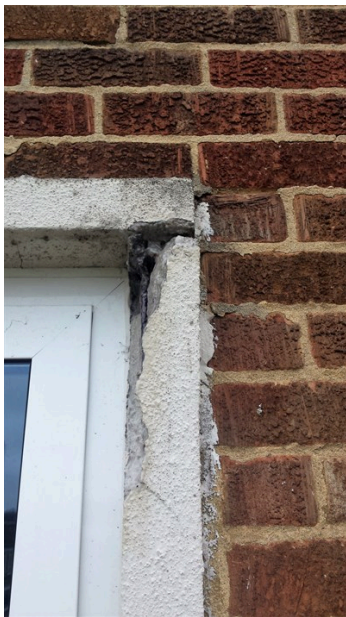
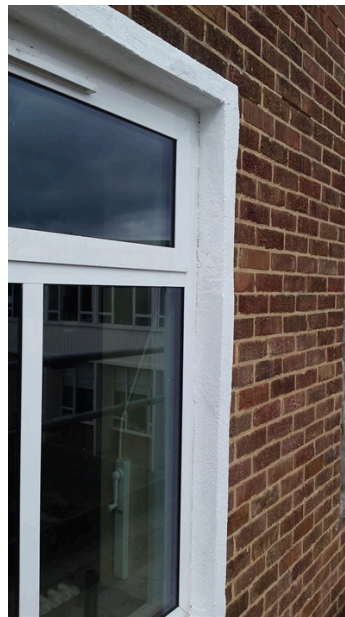
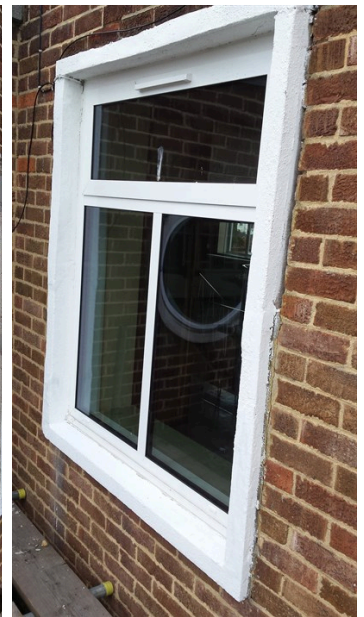
## Photograph Descriptions

*When the windows were replaced it became apparent that there were major issues with spalled concrete on many of the window sills and lintels. Large chunks of concrete were breaking away and causing a hazard for staff and pupils. The repairs had to be able to be carried out with minimum disruption to the school's usual activities.*

- \* A severely spalled corner piece ,
- \* A cracked and spalled lintel ,
- \* The repaired corner piece ,
- \* The repaired lintel ,

Application was carried out in accordance with Belzona Know-How System Leaflet WPA-4. All loose debris was removed and the area cleaned before applying Belzona 4911 followed by Belzona 4141 to restore the original profiles. No special shuttering was required and the repairs were carried out easily with trowels.
