LOCALIZED BELZONA REPAIRS TO RUBBER LININGS

ID: 6060

Industry: Power

Application: TCC-Tanks and Chemical Containment Areas

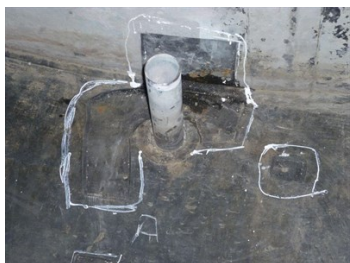
- * Defect areas marked up in a water treatment tank ,
- * Failed neoprene rubber lining being removed ,
- * Completed repairs with Belzona 2111 ,
- * Further repairs completed on tank walls ,
