BELZONA REPAIRS AND PROTECTS HEAT EXCHANGER

ID: 6061

Customer Location: Chemical plant, Croatia
Application Date: March 2011

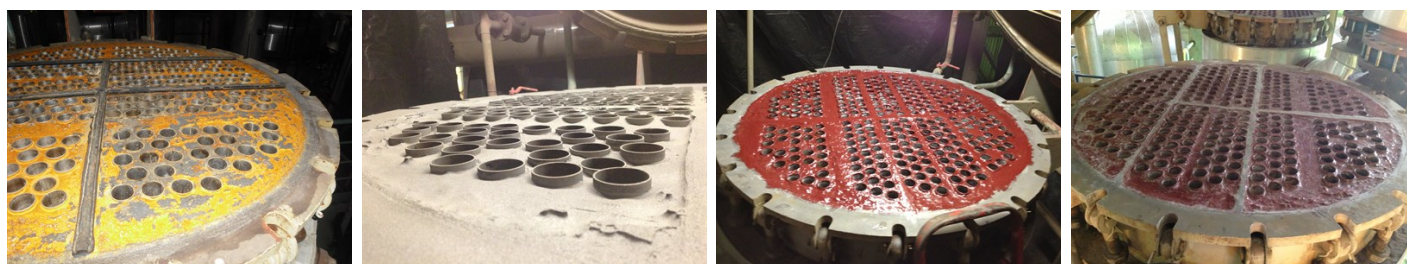
Photograph Descriptions

Severe corrosion/erosion on both ends of two heat exchangers,

- * Problem close up ,
- * Blasted surface ,
- * Repaired surface ,
- * After 3 years in service ,

Degradation of surface due to high temperature aggressive acidic media.

The application was carried out in accordance with Belzona Know-How System Leaflet HEX-1 and HEX-3.

The customer was in the process of sourcing quotes for a new heat exchanger. Belzona offered a lower cost alternative with minimal delay and disruption to production. Belzona has provided excellent protection.
