BELZONA REPAIRS AND PROTECTS HEAT EXCHANGER

Customer Location: *Chemical plant, Croatia*
 Application Date: *March 2011*

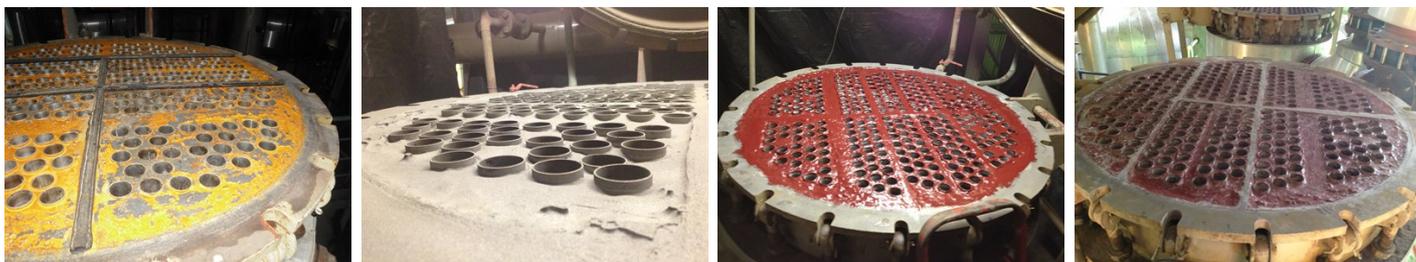
Severe corrosion/erosion on both ends of two heat exchangers,

- * Problem close up ,
- * Blasted surface ,
- * Repaired surface ,
- * After 3 years in service ,

Degradation of surface due to high temperature aggressive acidic media.

The application was carried out in accordance with Belzona Know-How System Leaflet HEX-1 and HEX-3.
